ISLANDER BEACH RESORT

PHASE 1 MILESTONE INSPECTION REPORT

PROJECT NO. 24-1380

Subject: **Phase 1 Milestone Inspection Report
Islander Beach Resort
1601 South Atlantic Avenue, New Smyrna Beach, Florida 32169**

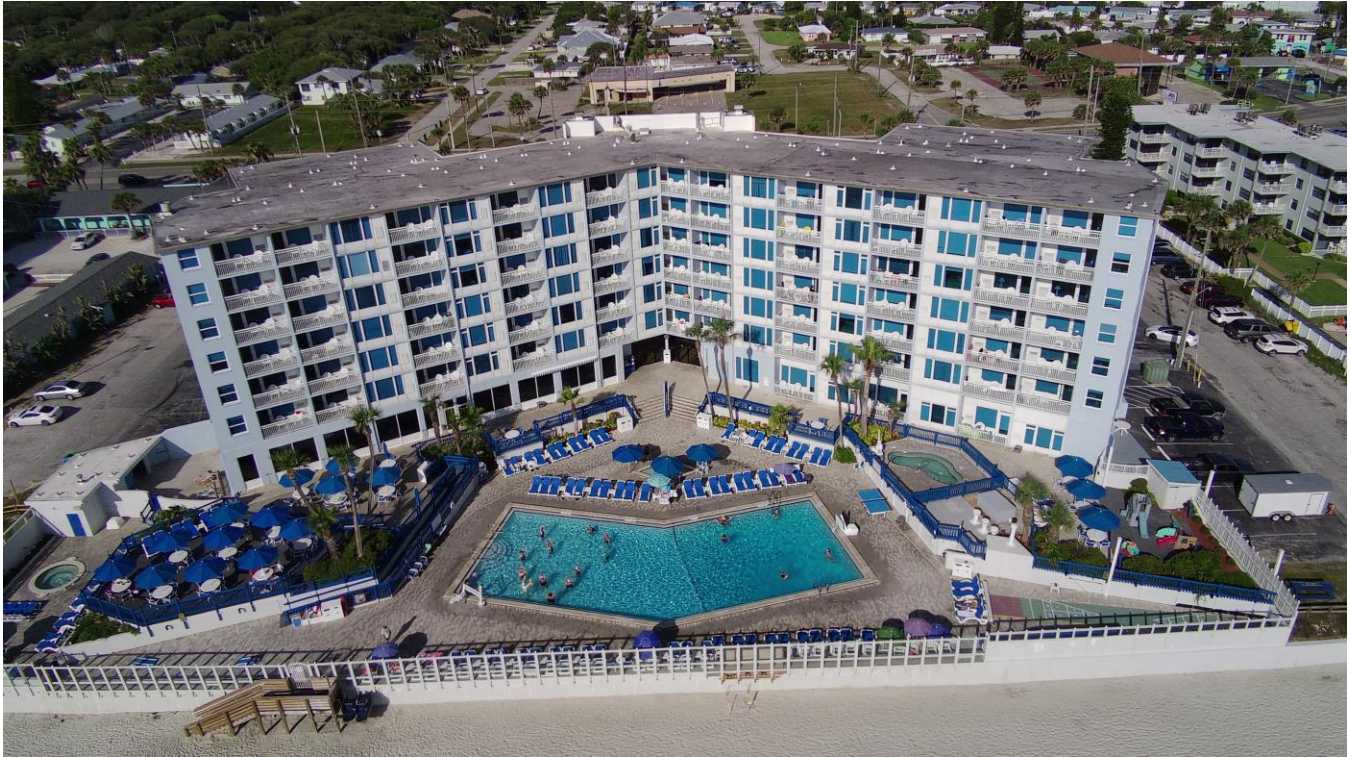
Photograph #1 – East building elevation

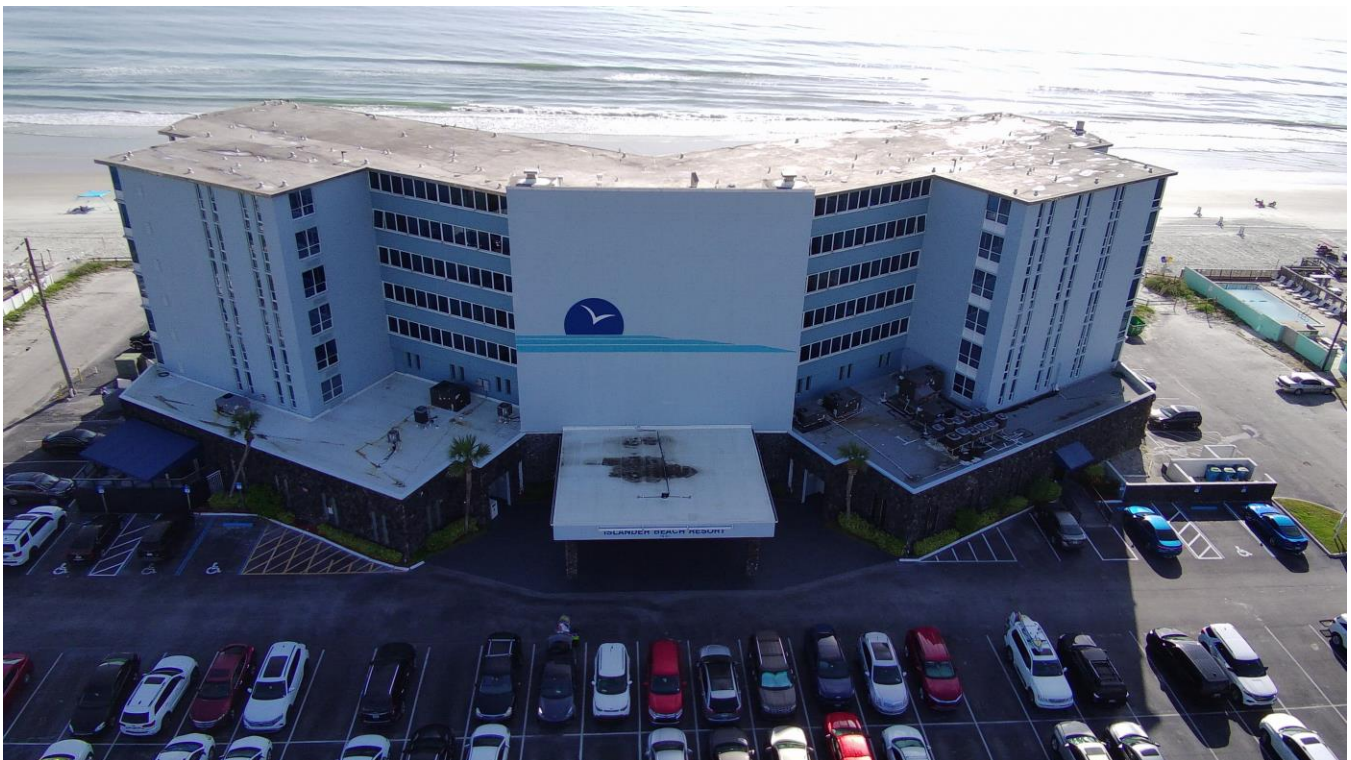
Photograph #2 – West building elevation

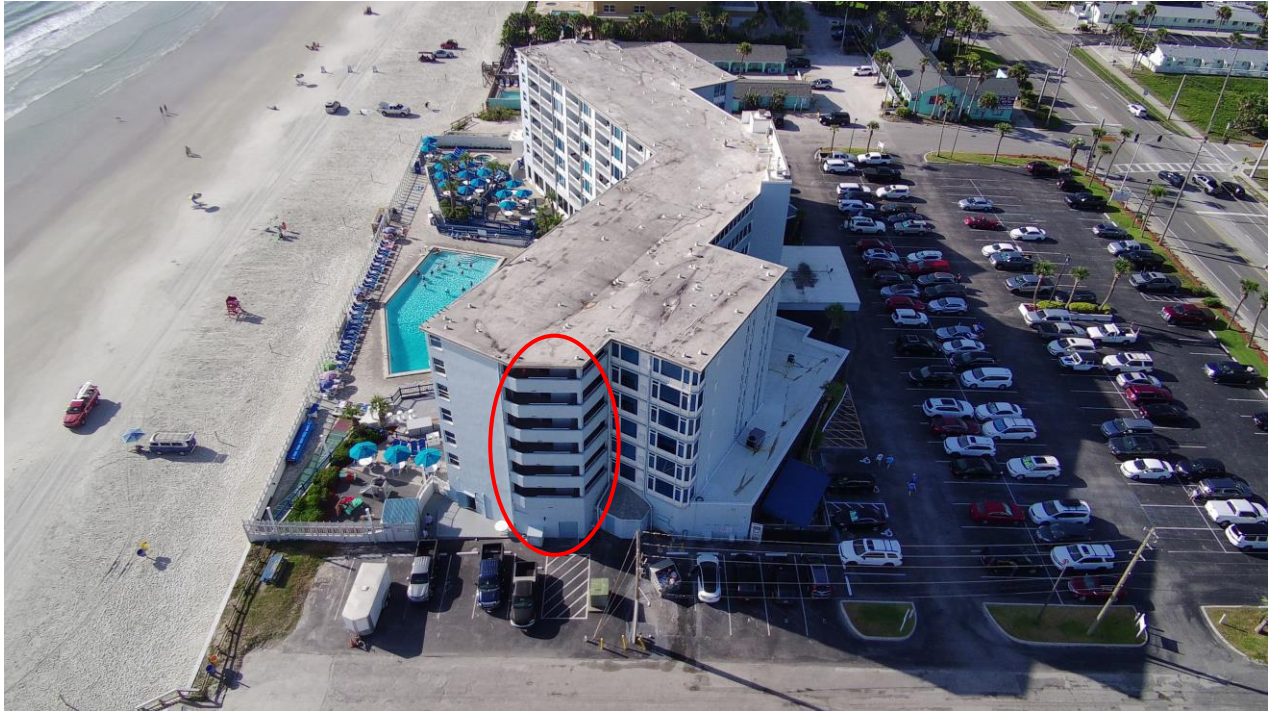
The building is in fair to poor structural condition. There was significant structural deterioration identified on the building at the North exterior walkway corridor on the slabs and columns and at the South walkway corridor on an exterior column (See photographs 3 and 4). The damage identified appears to be from the corrosion of the embedded reinforcing steel; therefore, a Phase 2 inspection is not recommended. There is a significant amount of concrete spalling damage at the exterior of the structure and a moderate amount of spalling damage on the interior on the building on the slabs and columns.

There is significant structural deterioration at the North walkway corridor slabs adjacent to the 01 stack units (See photograph 3). Widespread spalling damage was observed at the top, bottom and edge of the slabs in that area. The exterior South walkway corridor had localized spalling damage on the slab.

Concrete damage was identified at (31) columns at the North and South walkway corridors. More extensive size spalls were identified at the exterior column at the North and South walkway corridors (See photograph 3 and 4). The damage at the South walkway exterior column is considered significant structural deterioration at floors 4 through 1.

Photograph #3 – North building elevation (North walkway corridor with significant damage circled)

It is our understanding that all concrete damage at the North half of the building will be repaired in the next 3-5 months. During that project, we recommend the column damage at the South exterior walkway also be repaired or shoring be installed. It is our understanding that the concrete damage at the South half of the building will be repaired in the next 15-18 months, which aligns with our recommended time frame.

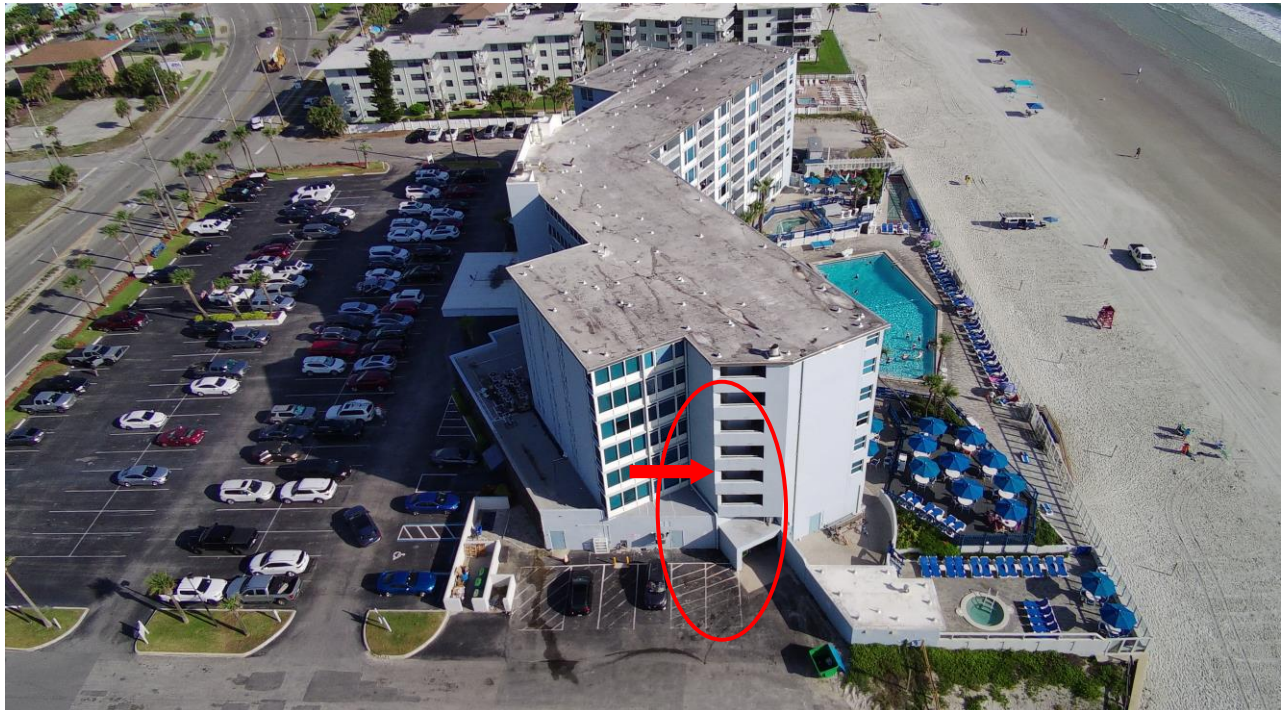
Photograph #4 – South building elevation (South walkway column with significant damage circled)

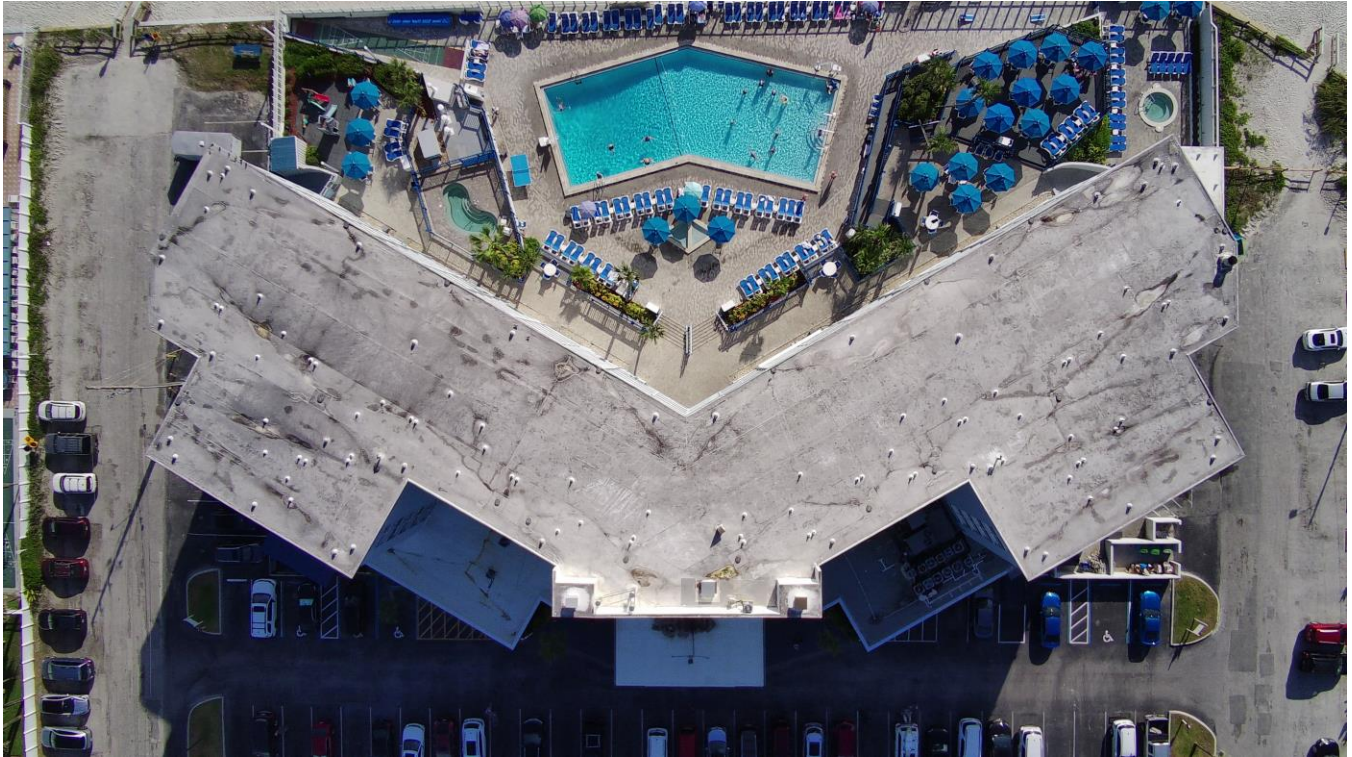
Photograph #5 – Roof layout

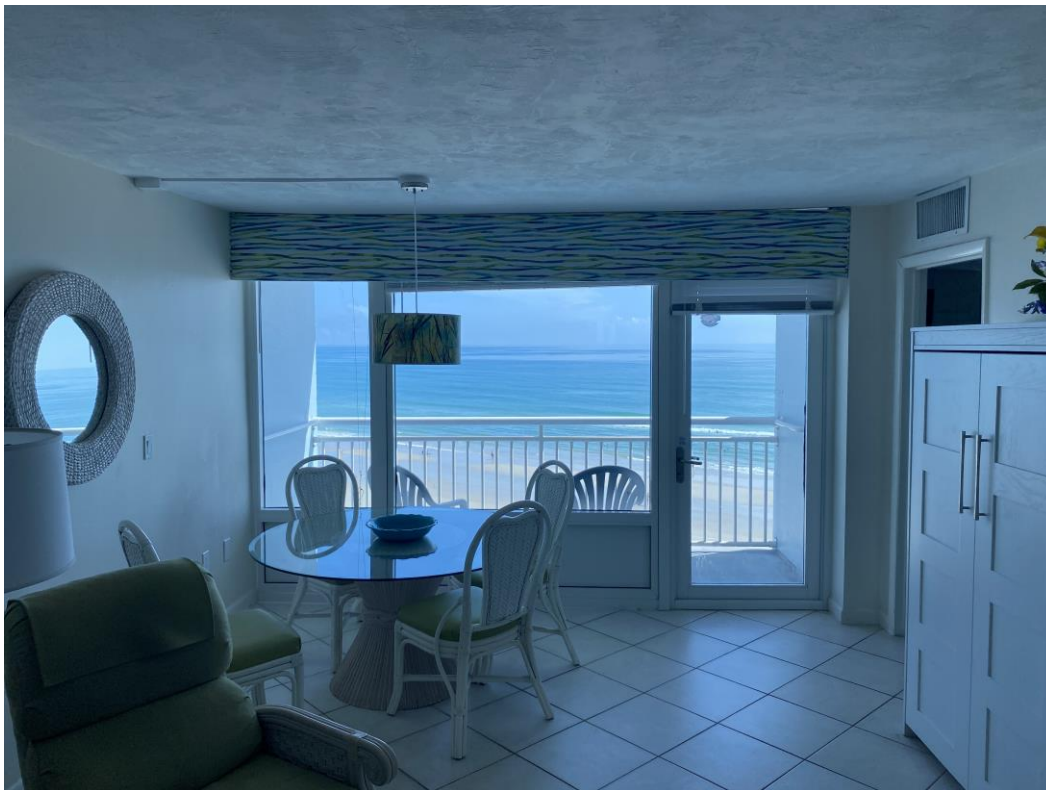
Photograph #6 – Typical interior and balcony layout

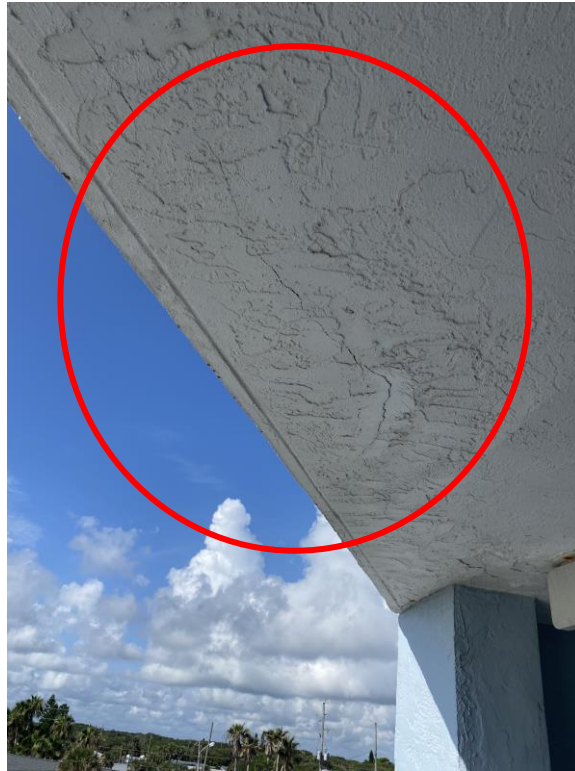
Photograph #7 – Typical slab edge crack at South walkways

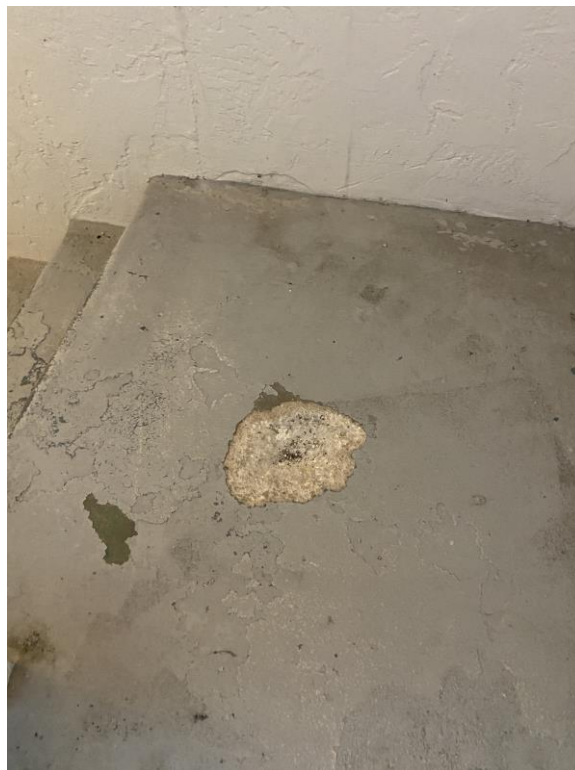
Photograph #8 – Typical top slab spalling damage

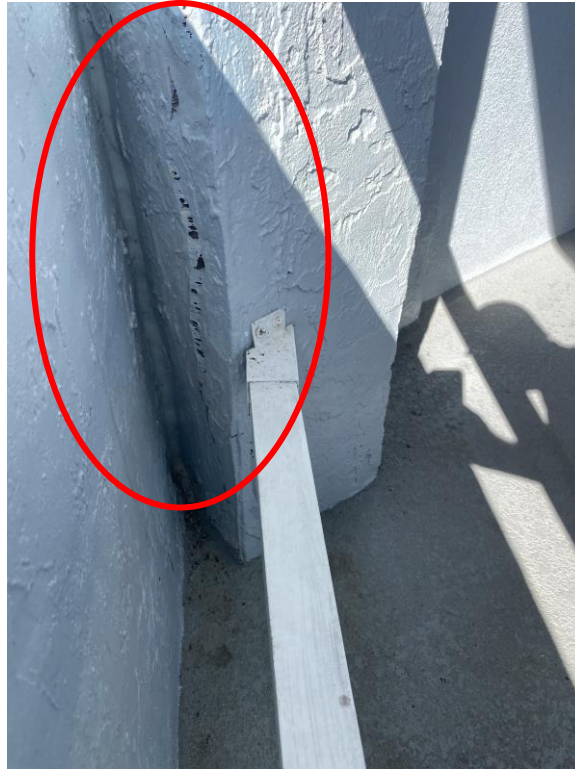
Photograph #9 – Severe column damage at South walkway recommended for immediate repair

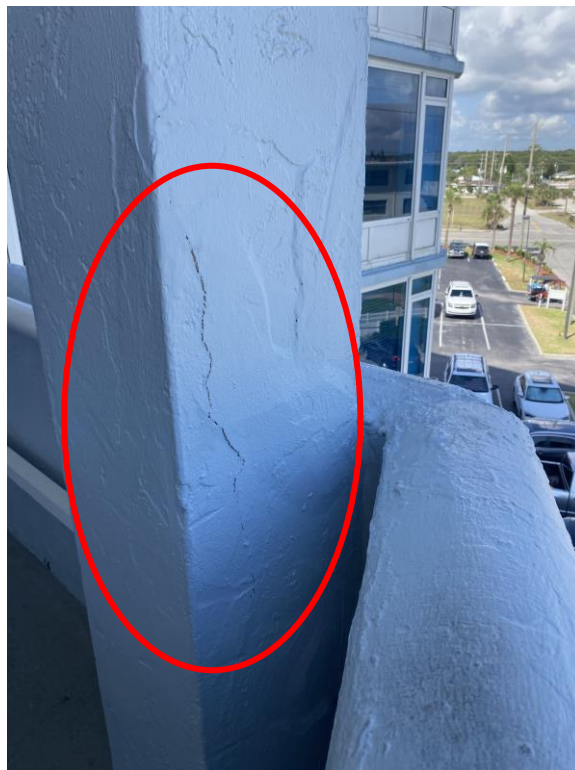
Photograph #10 – Column damage at North walkway recommended for immediate repair

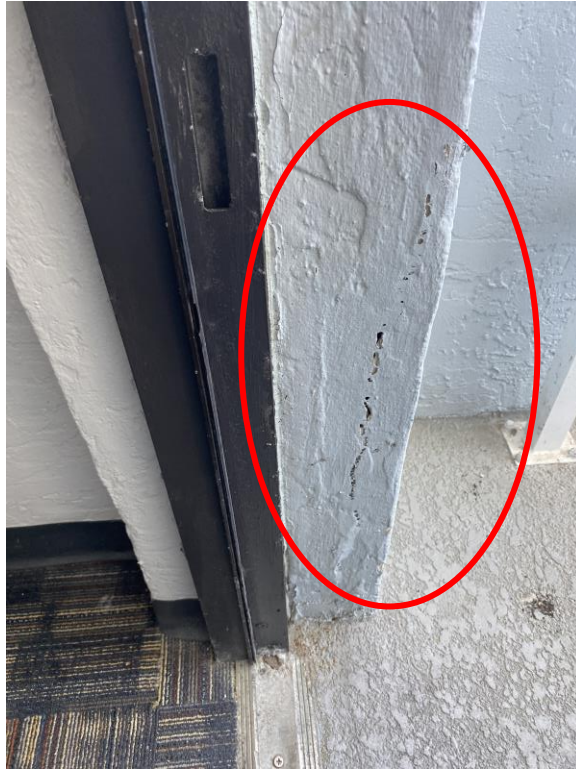
Photograph #11 – Typical walkway column spall at doorway

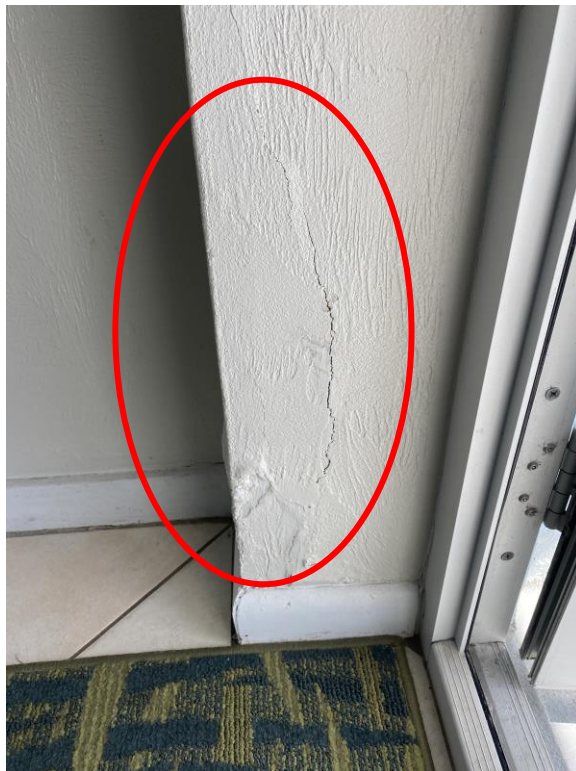
Photograph #12 – Typical column spall at unit interior
